## **An Innovative Solution for the Repair of the Sepulveda Feeder**

By: Michael McReynolds P.E.<sup>1</sup>

### Abstract

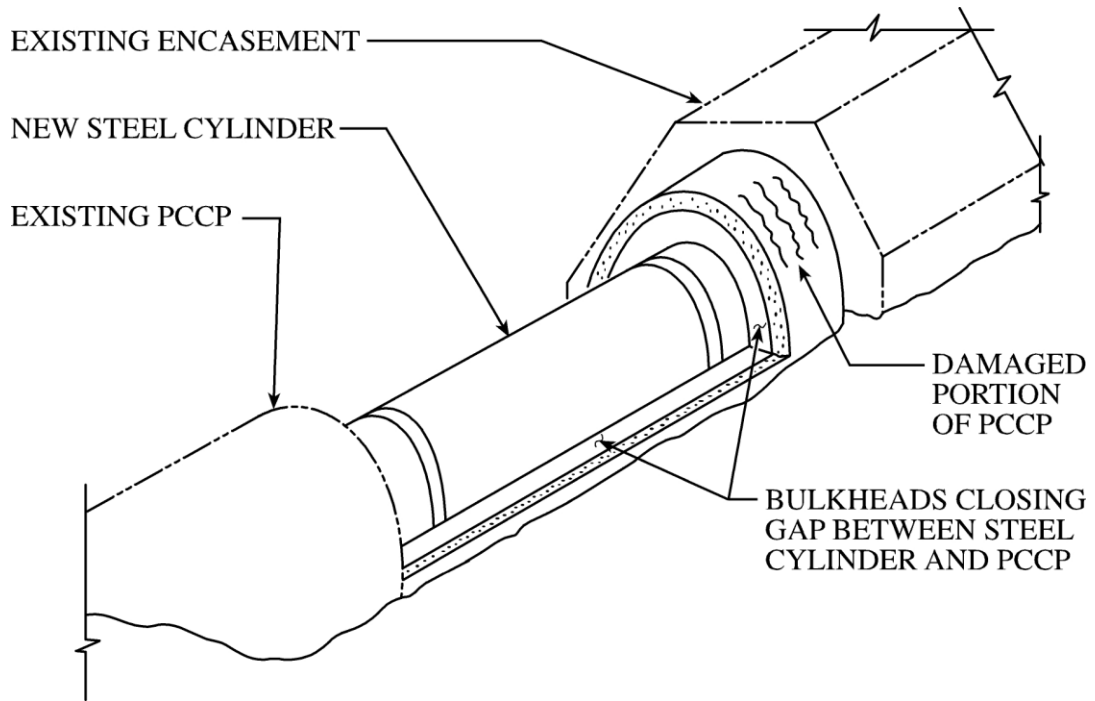
BULKHEAD FOR GROUTING GAP BETWEEN CYLINDER AND PCCP  
FIGURE 2

During this phase of the construction, grout was pouring out through the cracks in the damaged PCCP. This threatened to make the repair worthless because the annular space between the PCCP and the steel cylinders could not be filled with grout. This problem was solved by sealing the cracks where grout was escaping with rapid set concrete. The rapid set concrete was mixed with hot water so that it would set up in a matter of minutes. The rapid set concrete was pushed into the cracks and was able to hold enough pressure for the grouting to be completed.

The next phase of the repair consisted of welding steel plates between the existing pipe and the new cylinders (See Figure 2). This was done to close the annular space between the existing concrete pipe and the new steel cylinders so they could be filled with grout. The annular space between the concrete pipe and new steel cylinders was then filled with grout through couplings in the new steel cylinders.
